POLL * **Q38** **88-036846/08** ***DD-249-688-A**
Load supporting equipment for factory crane - is hollow beam with
central crane hook connector between load carrying cross members
VEB POLYGRAPH LEIPZIG 05.08.88-DD-290973
(16.09.87) B66c-01/16

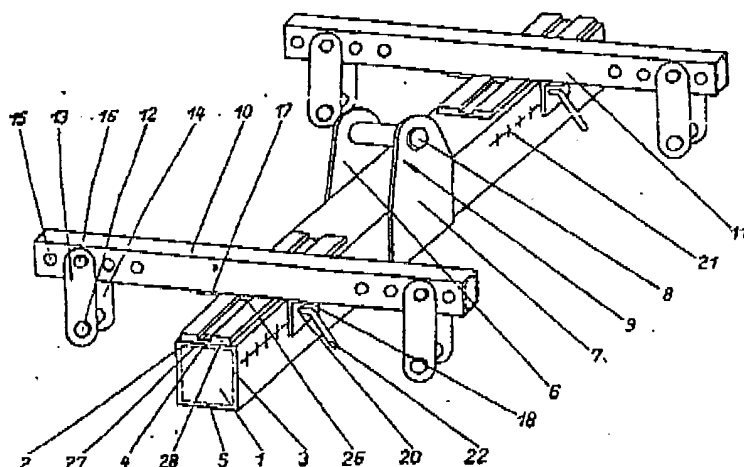
A hollow beam has a central connection for the lifting hook of the crane. At each end is a forked support secured by a bolt passing through a hole in the beam. Both sides of the support projects a cross member, connected so that a minimum height is required. This has a connector at each end.

USE - Load handling device of minimum height enabling a crane installed in a warehouse or factory to be used effectively.
(Dwg.No.1)
N88-027887
